**Report on the Efficacy and Comparative Costs of Using Flow Devices to  
Resolve Conflicts with North American  
Beavers along Roadways in the  
Coastal Plain of  
Virginia**

**May 10, 2006**

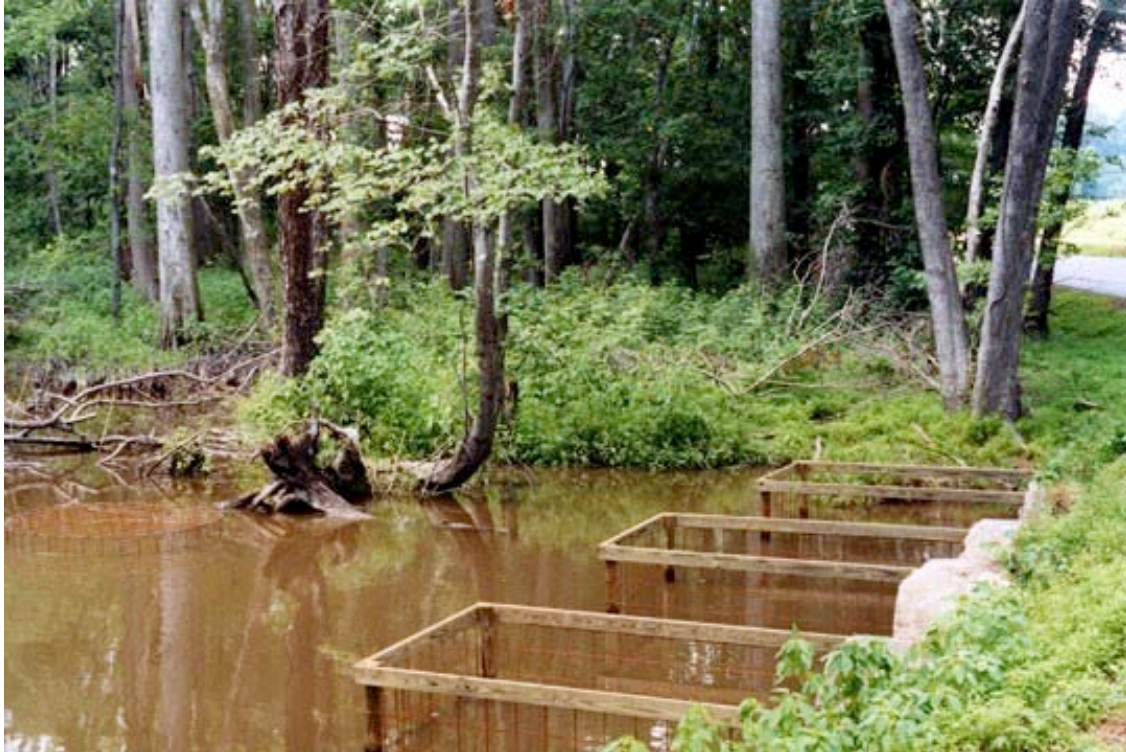
**Figure 6. Three Beaver Deceivers™ installed in June 2004 to protect five culverts directing water underneath Route 644 near Lake Cohoon in the City of Suffolk, Virginia. A Round Fence™ (left center) and a Castor Master™ (beneath the surface of the water between the Round Fence™ and the center Beaver Deceiver™) were attached to the upstream end of the center Beaver Deceiver™ to augment water flow if beavers attempted to dam the fences.**

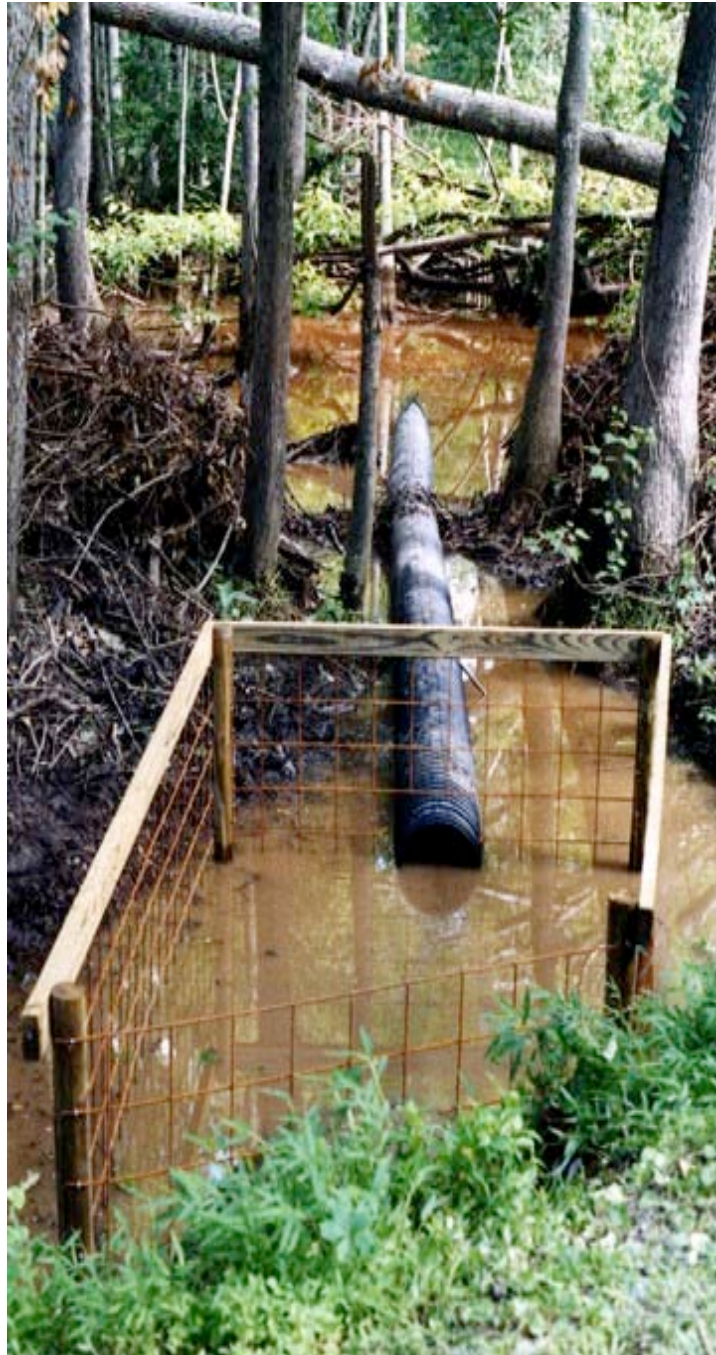
**Figure 7. A Beaver Deceiver™ installed in June 2004 to protect a culvert directing water underneath Route 644 on Kingsale Swamp in the City of Suffolk, Virginia. A Round Fence™ (top center) and a Castor Master™ (between the Round Fence™ and the Beaver Deceiver™) were attached to the upstream end of the Beaver Deceiver™ to augment water flow.**

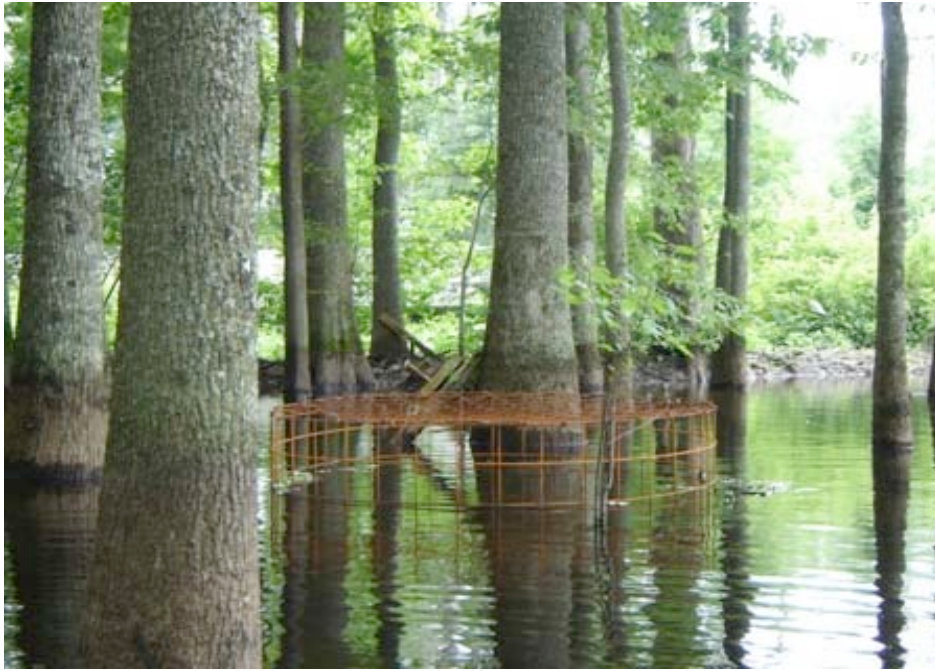
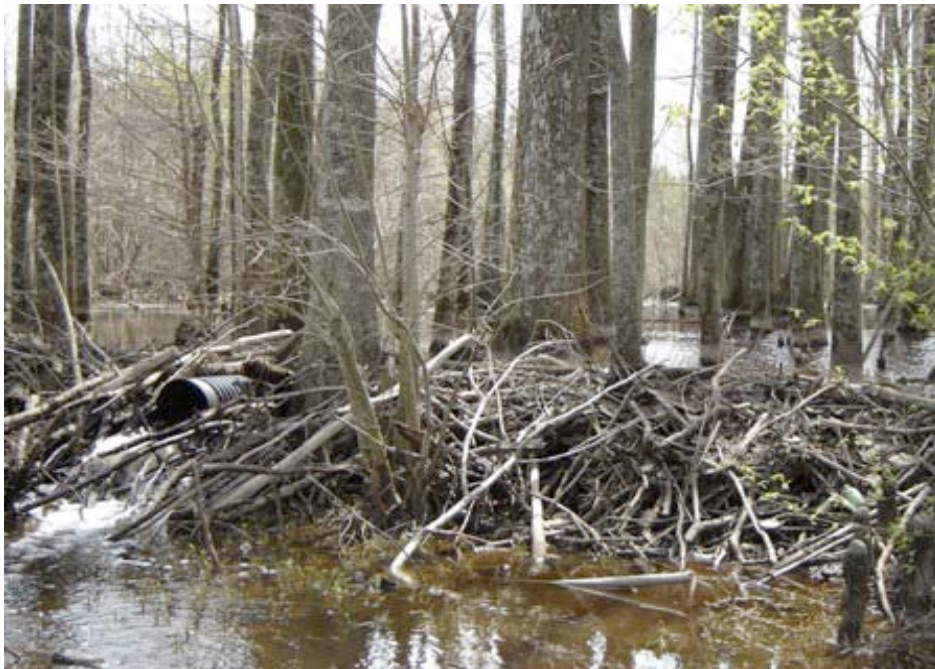
**Figure 9. The upstream (a) and downstream (b) views of a Round Fence™ (a) and Castor Master™ (b) installed through an existing beaver dam in May 2005 to protect a bridge directing water underneath Route 611 on Corrowaugh Swamp in Isle of Wight County, Virginia.**

9. The upstream (a) and downstream (b) views of a Round Fence™ (a) and Castor Master™ (b) installed through an existing beaver dam in May 2005 to protect a bridge directing water underneath Route 611 on Corrowaugh Swamp in Isle of Wight County, Virginia. 27

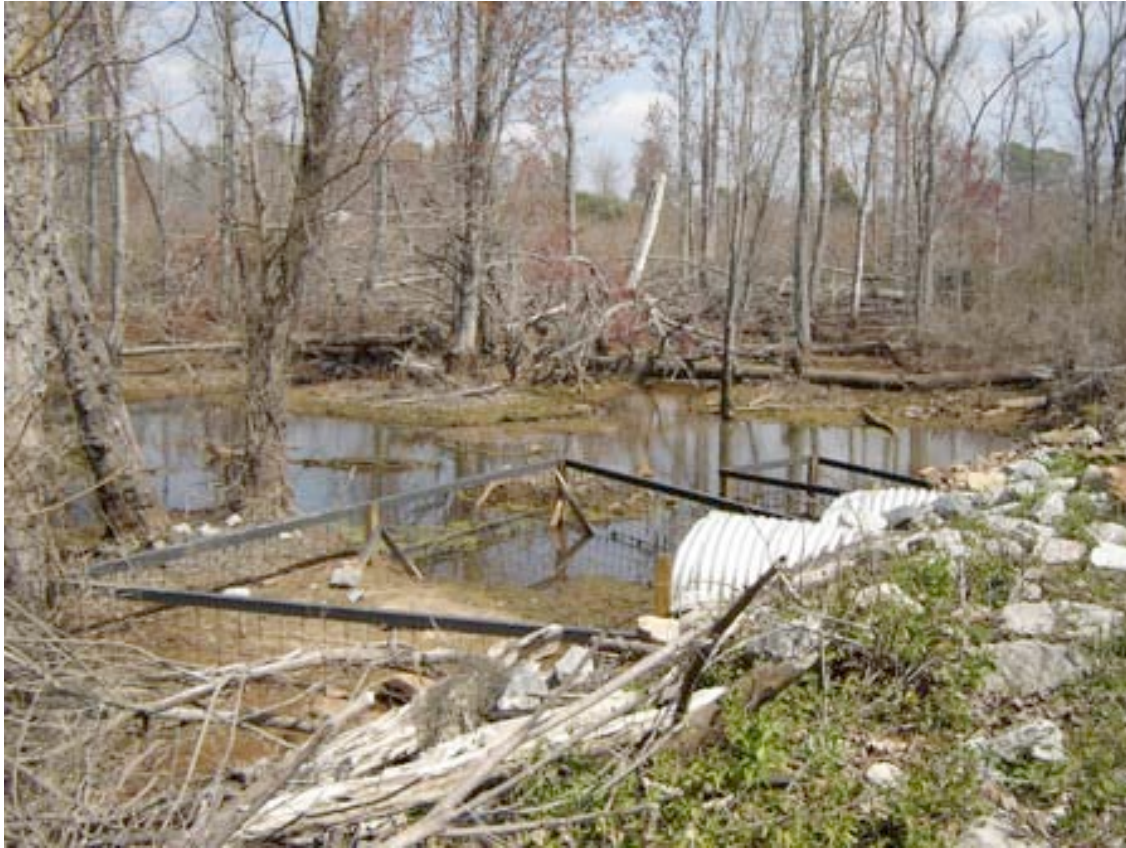
**Figure 10. Two Beaver Deceivers™ installed in November 2005 to protect two culverts directing water underneath Route 619 on Craney Creek in Gloucester County, Virginia.**

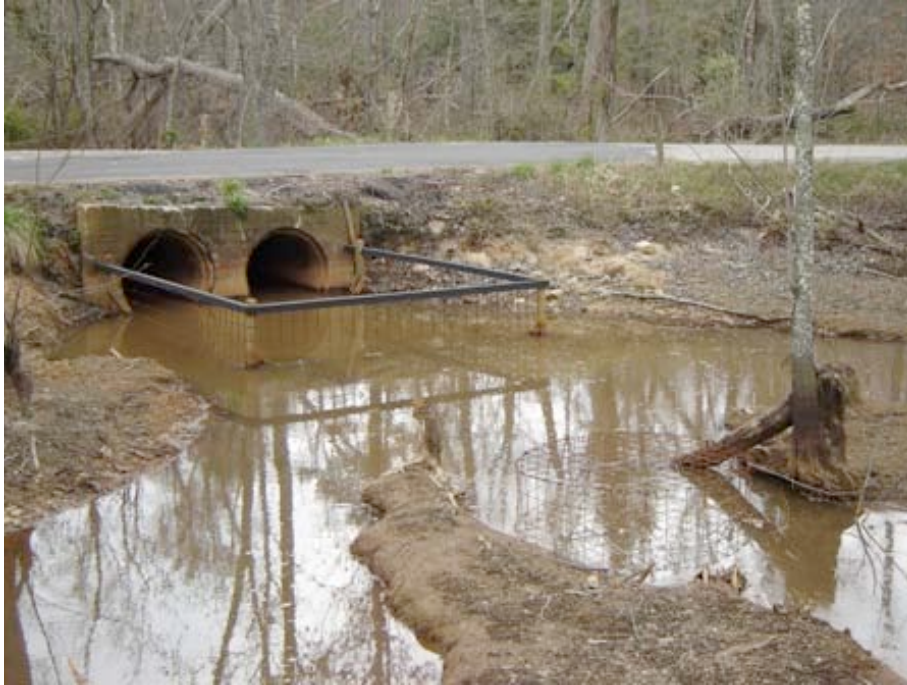
**Figure 11. A Beaver Deceiver™ installed in November 2005 to protect two culverts directing water underneath Route 606 on Briary Swamp in Middlesex County, Virginia. A Round Fence™ (bottom center) and a Castor Master™ (beneath the surface of the water between the Round Fence™ and the Beaver Deceiver™) were attached to the upstream end of the Beaver Deceiver™ to augment water flow if beavers attempted to dam the fence.**

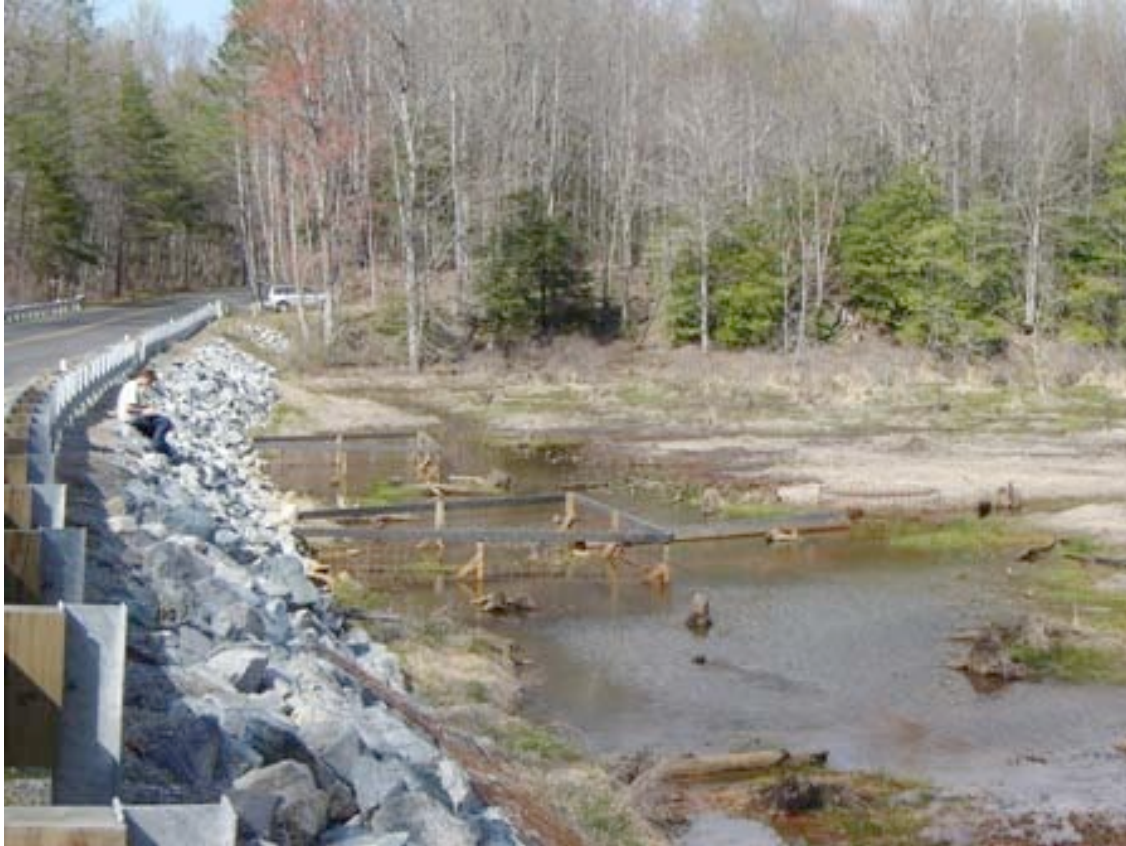
**Figure 12. Two Beaver Deceivers™ installed in January 2005 to protect two culverts directing water underneath Route 624 on Pope's Creek in Westmoreland County, Virginia. A Round Fence™ (right center) and a Castor Master™ (between the Round Fence™ and the large Beaver Deceiver™) were attached to the upstream end of one Beaver Deceiver™ to augment water flow if beavers attempted to dam the fences.**

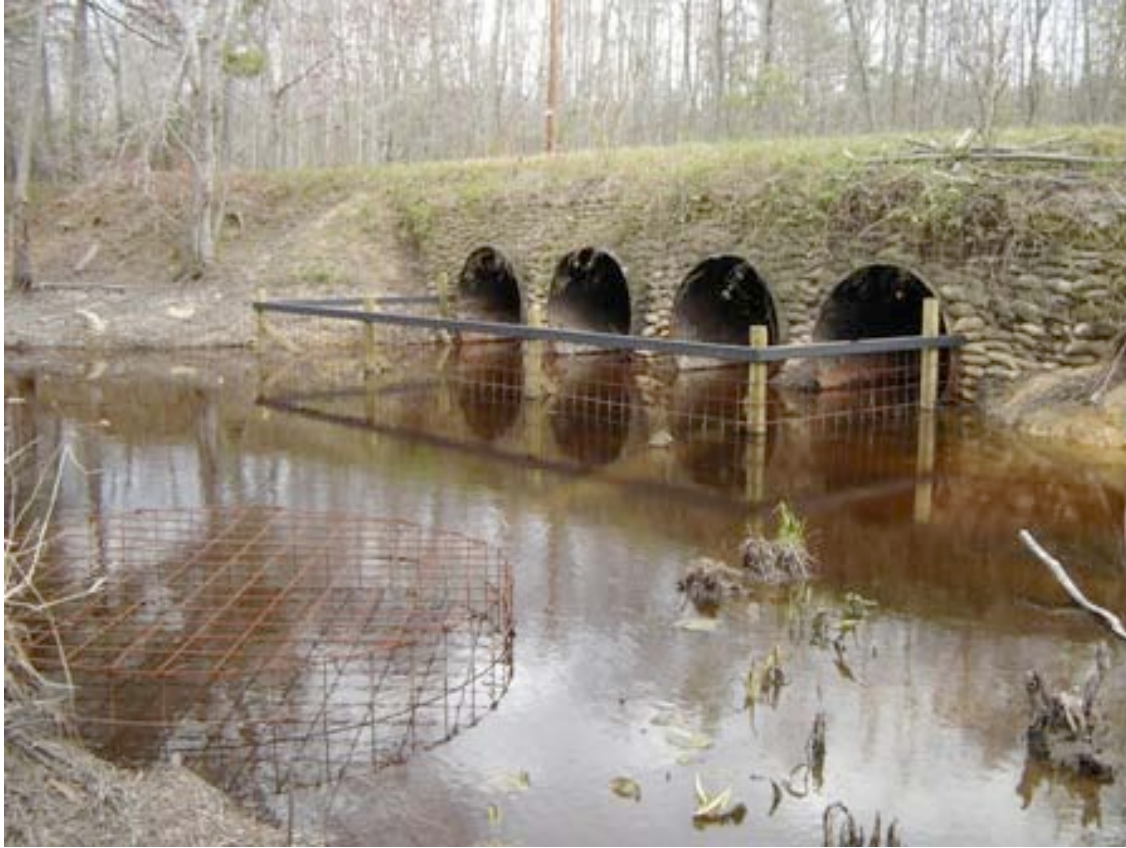
**Figure 13. A Beaver Deceiver™ installed in November 2005 to protect four culverts directing water underneath Route 639 on Pope's Creek in Westmoreland County, Virginia. A Round Fence™ (bottom left) and a Castor Master™ (beneath the surface of the water between the Round Fence™ and the Beaver Deceiver™) were attached to the upstream end of the Beaver Deceiver™ to augment water flow if beavers attempted to dam the fence.**

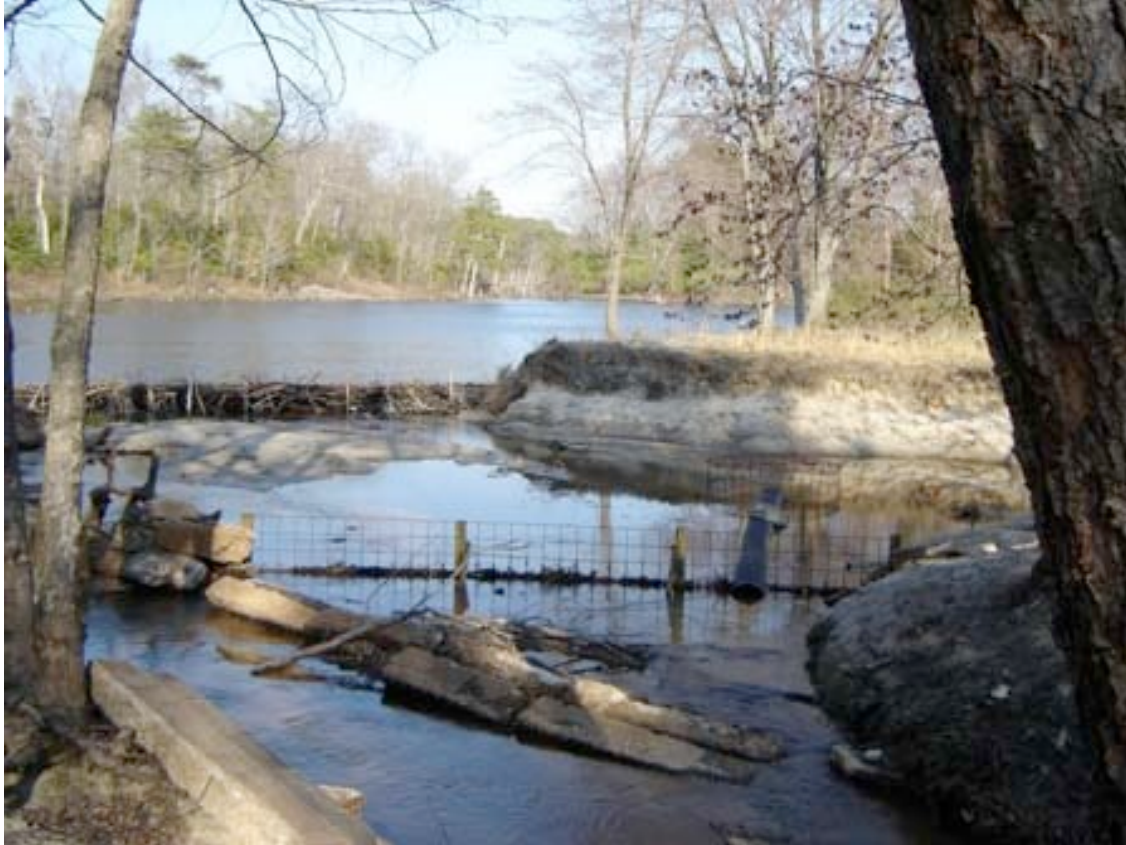
**Figure 14. A diversion dam (left center), a Round Fence™ (lower right), a Castor Master™ (lower right) and receiver fence (lower center) installed in November 2005 to protect three culverts directing water underneath Route 616 on Newton's Pond in Westmoreland County, Virginia.**

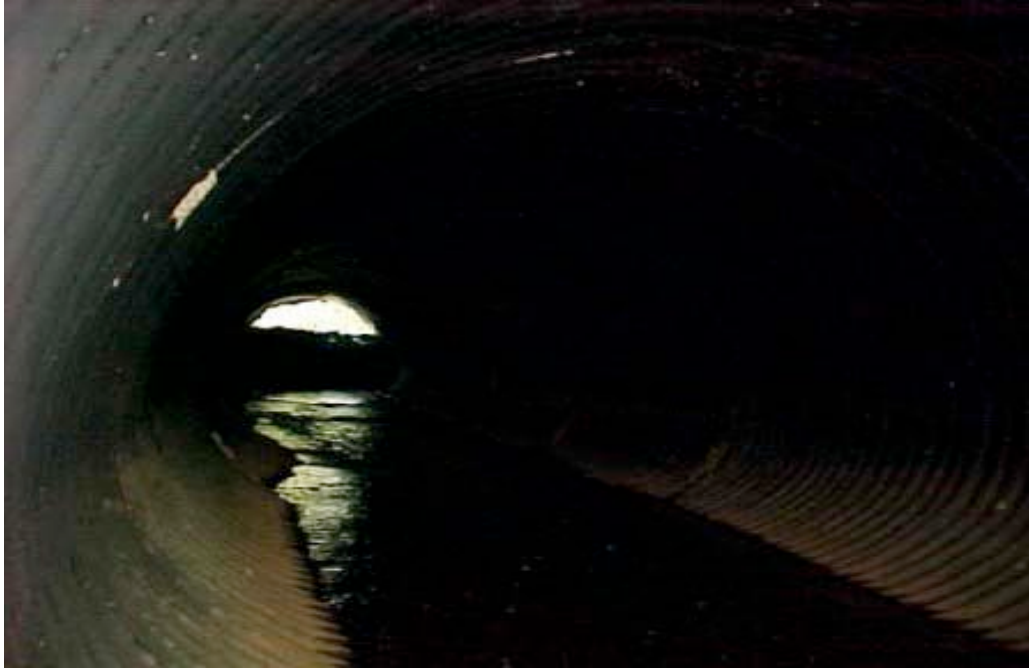
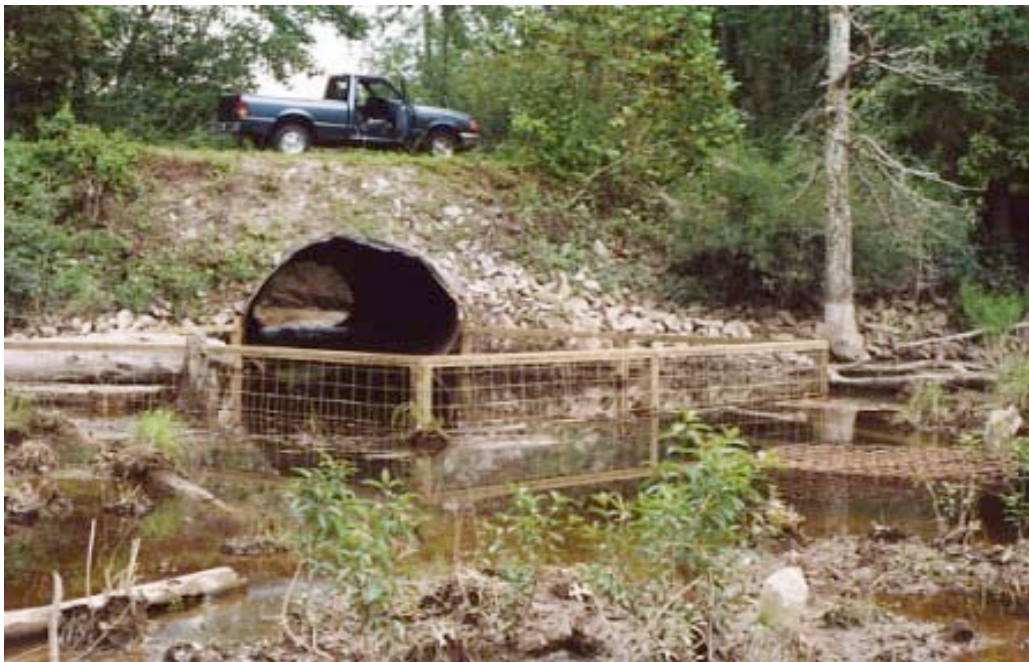
**Figure 15. (a) The view looking upstream of a plugged culvert underneath Route 664 on Winterpock Creek in Chesterfield County, Virginia prior to flow device installations. (b) View looking downstream of a Beaver Deceiver™, a Round Fence™ (lower right), and a Castor Master™ (beneath the surface of the water between the Round Fence™ and the Beaver Deceiver™) installed in August 2004 to protect the culvert beneath Route 664.**

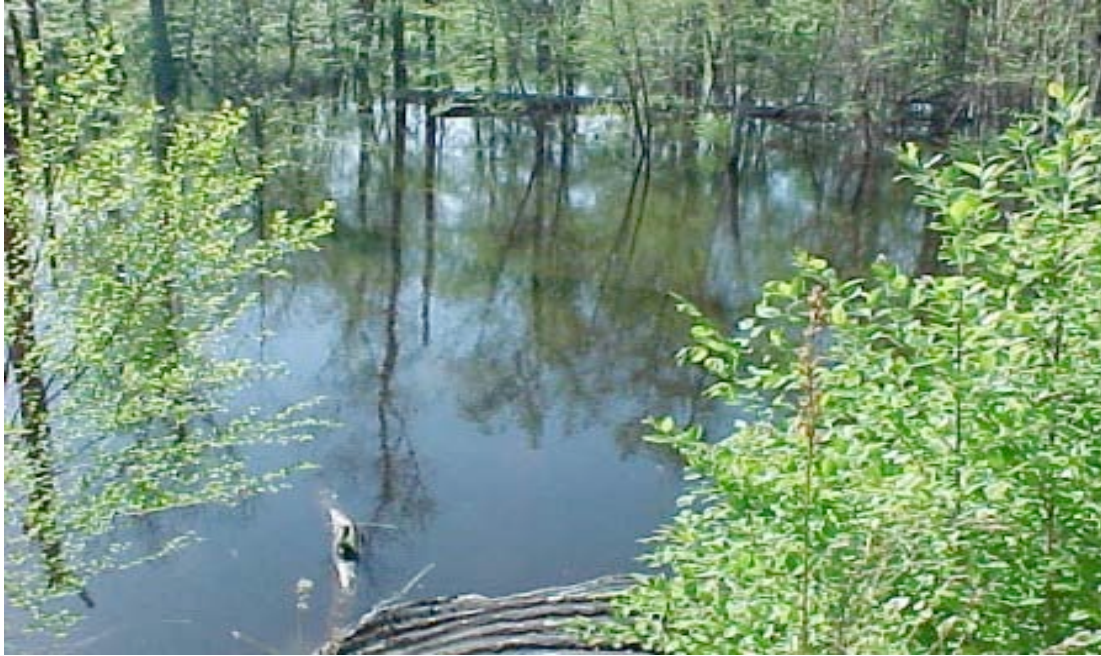
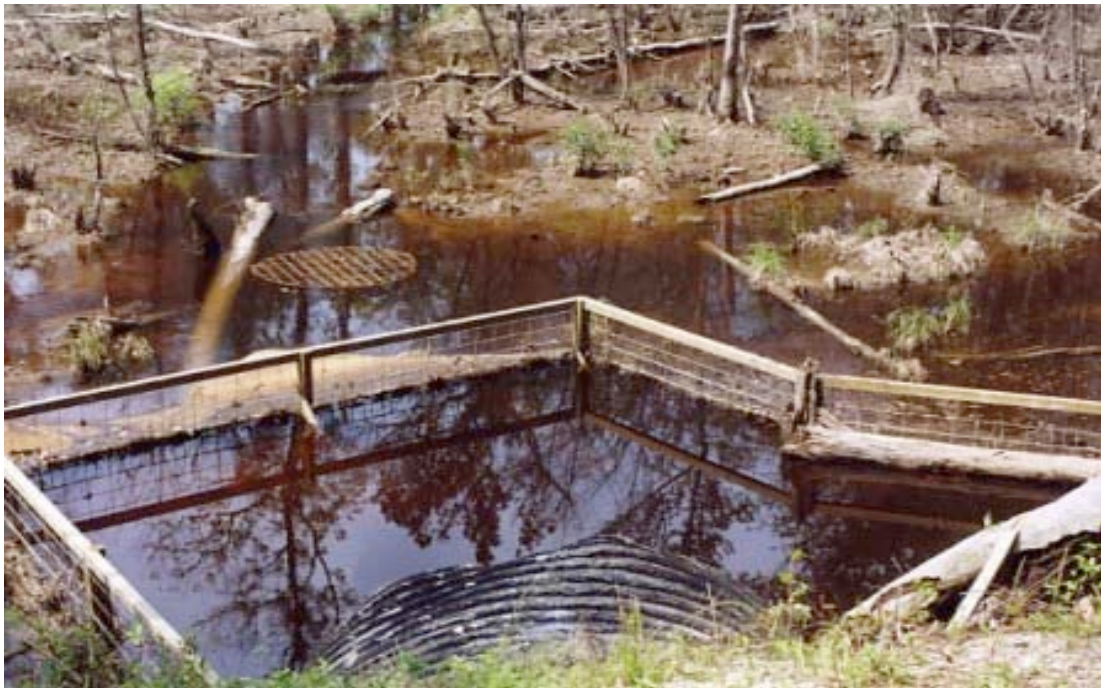
**Figure 16. (a) The view looking upstream above a plugged culvert beneath Route 664 on Winterpock Creek in Chesterfield County, Virginia in July 2004. (b) View looking upstream above a Beaver Deceiver™, a Round Fence™ (center left) and a Castor Master™ (beneath the surface of the water between the Round Fence™ and the Beaver Deceiver™) installed in August 2004 to protect the culvert beneath Route 664.**

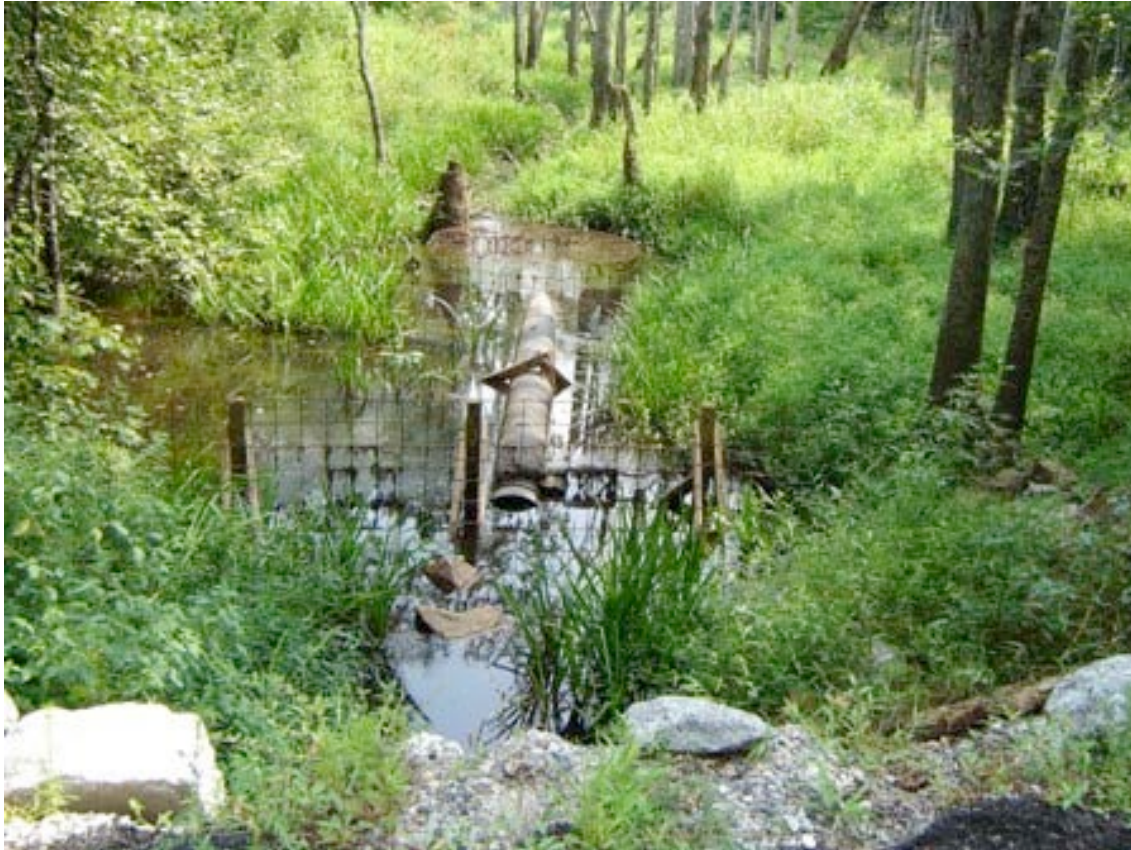
**Figure 17. A Round Fence™ (top center) and a Castor Master™ (between the Round Fence™ and the receiver fence) attached to the upstream side of a receiver fence installed in May 2005 to protect a culvert directing water underneath Route 630 on Swift Creek in Chesterfield County, Virginia.**

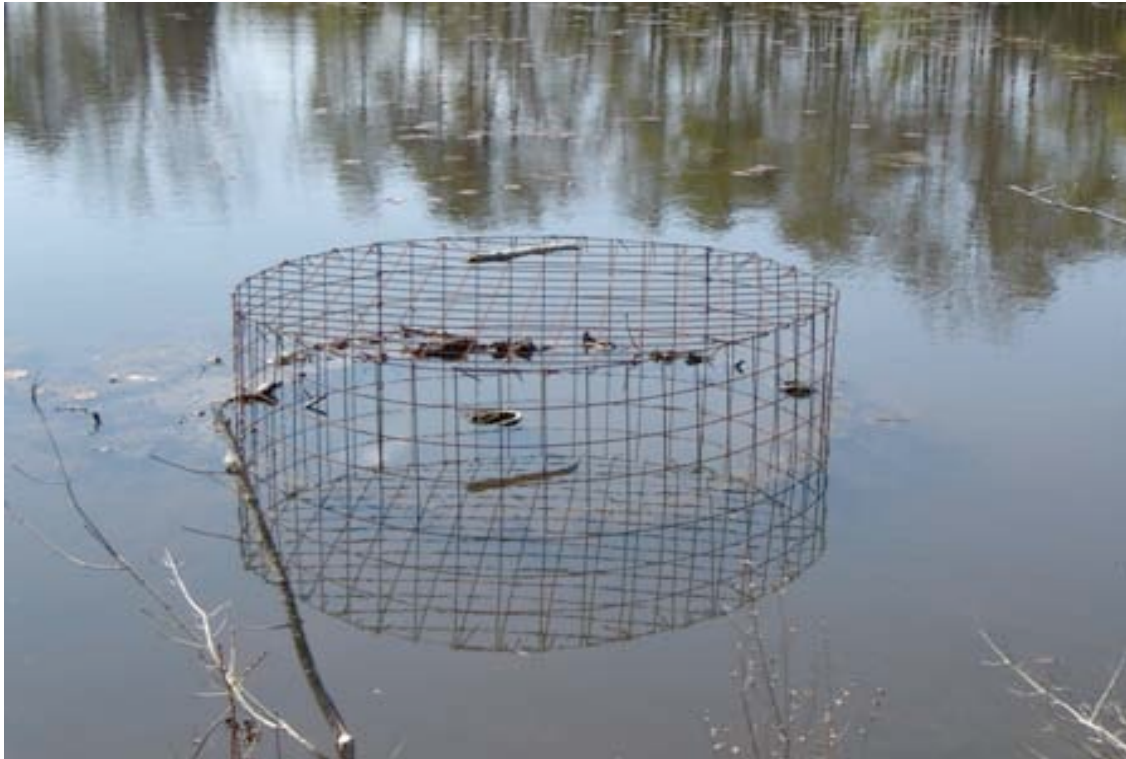
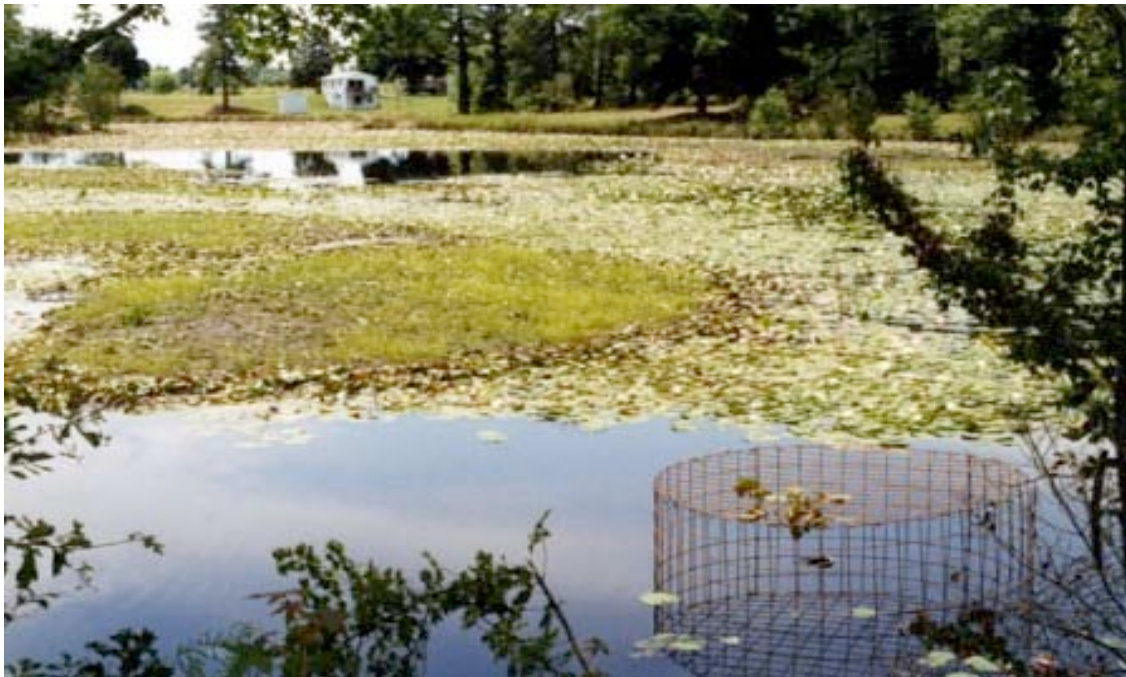
**Figure 18. A Round Fence™ (a and b) installed in June 2004 to protect a vertical culvert directing water underneath Route 1102 on Blackwater Swamp in Prince George County, Virginia.**

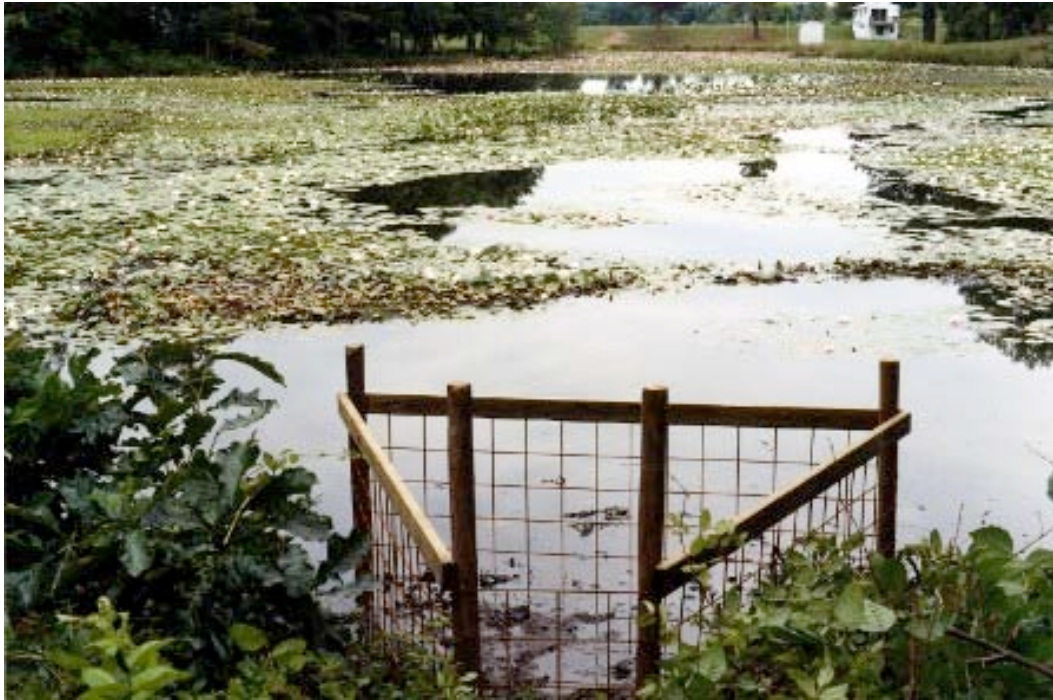
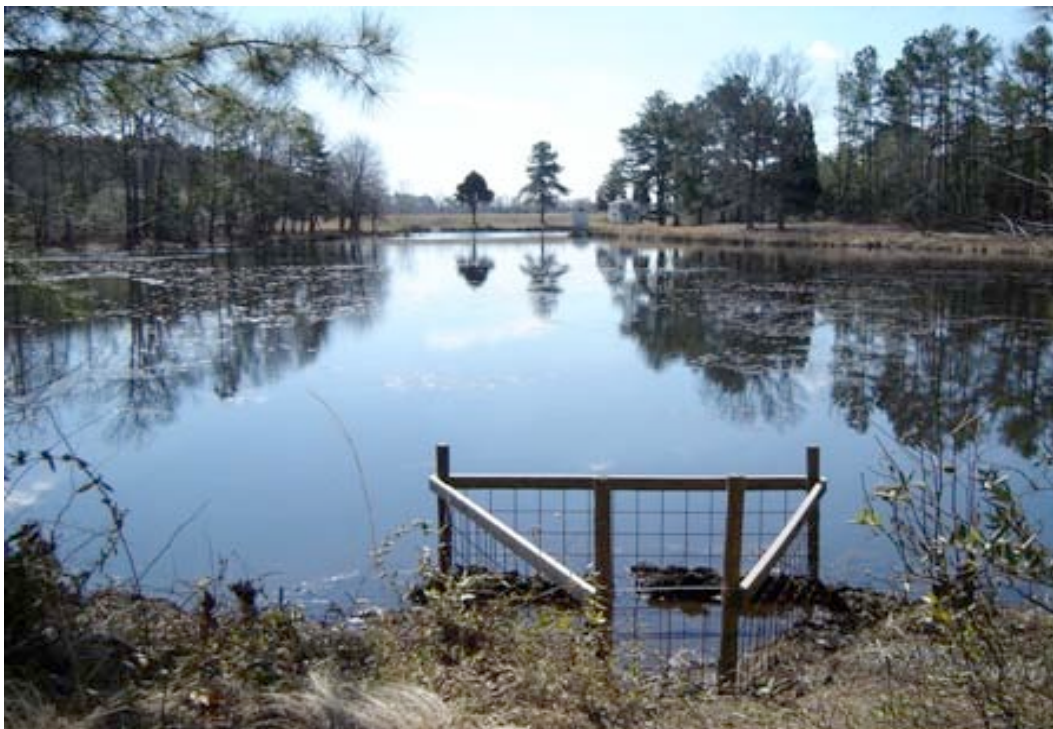
**Figure 19. A Beaver Deceiver™ installed to protect an overflow culvert directing water away from Route 1102 on Blackwater Swamp in Prince George County, Virginia in June 2004. Photo (a) was taken in summer and photo (b) was taken in winter.**

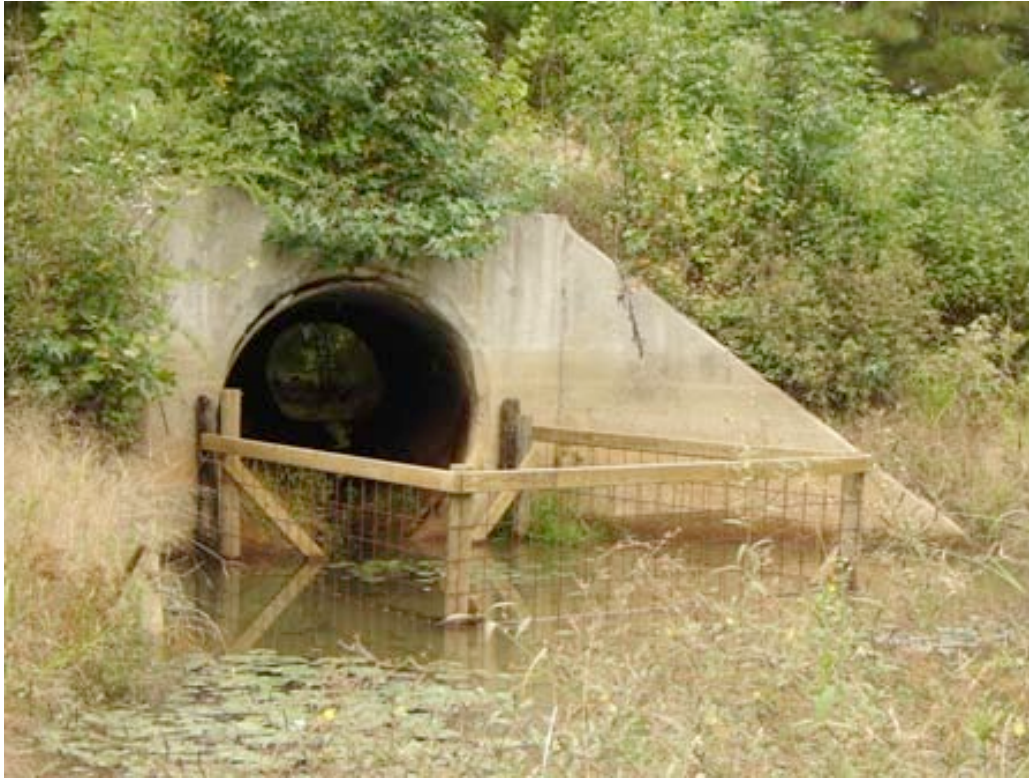
**Figure 20. A Beaver Deceiver™ installed in May 2005 to protect culvert directing water underneath Route 1102 on Blackwater Swamp in Prince George County, Virginia.**

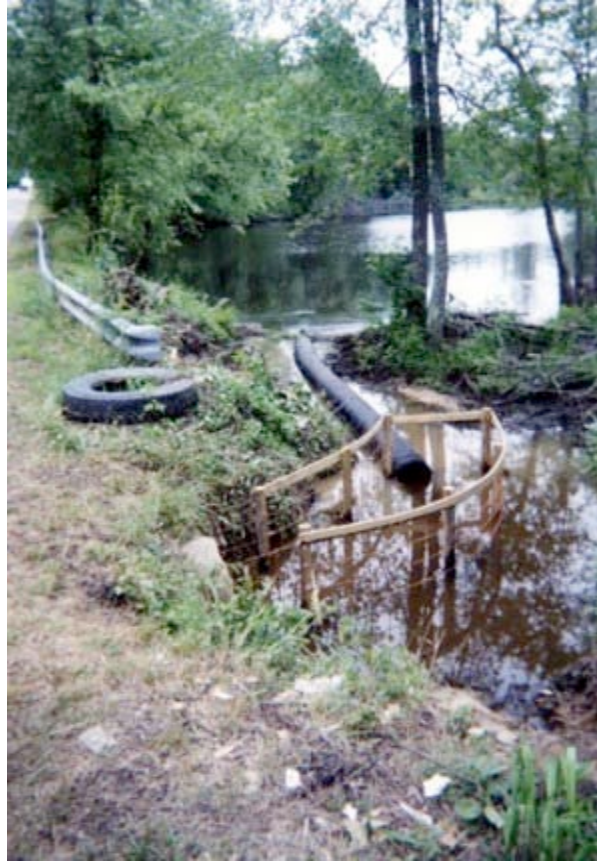
**Figure 21. A Beaver Deceiver™ installed in June 2004 to protect a culvert directing water underneath Route 630 on Second Swamp in Prince George County, Virginia. A Castor Master™ (center) and a Round Fence™ (beneath the surface of the water and attached to the upstream end of the Castor Master™) were attached to the upstream end of the Beaver Deceiver™ to augment water flow if beavers attempted to dam the fence.**

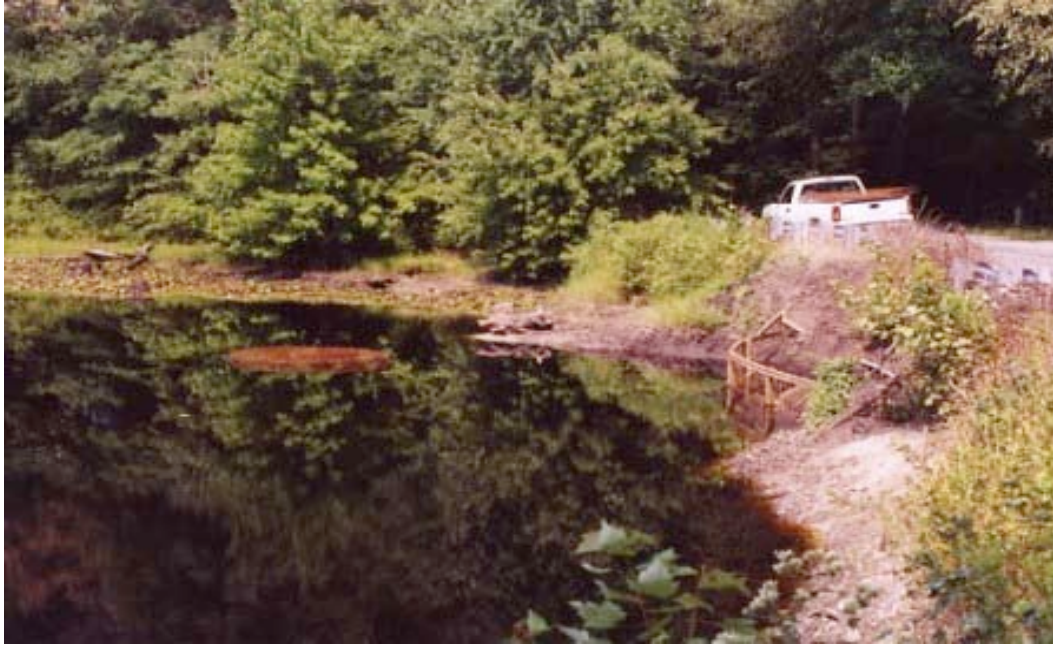
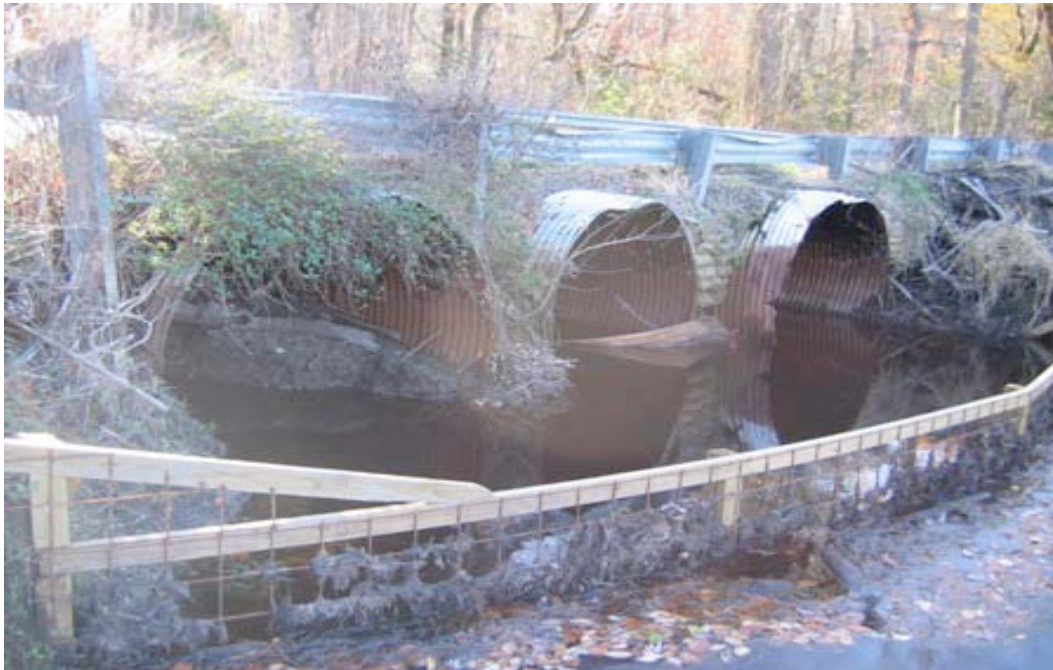
**Figure 22. (a) A Beaver Deceiver™ (right center) installed in August 2004 to protect three culverts directing water underneath Route 650 on Indian Swamp in Prince George County, Virginia. Two Round Fences™ (one is visible center left and the other is beneath the surface of the water) and two Castor Masters™ (beneath the surface of the water) were attached to the upstream end of the Beaver Deceiver™ to augment water flow. The top photo (a) was taken facing northeast and the bottom photo (b) was taken facing southwest.**
